Hull Waste Water

Atlantic, Ocean

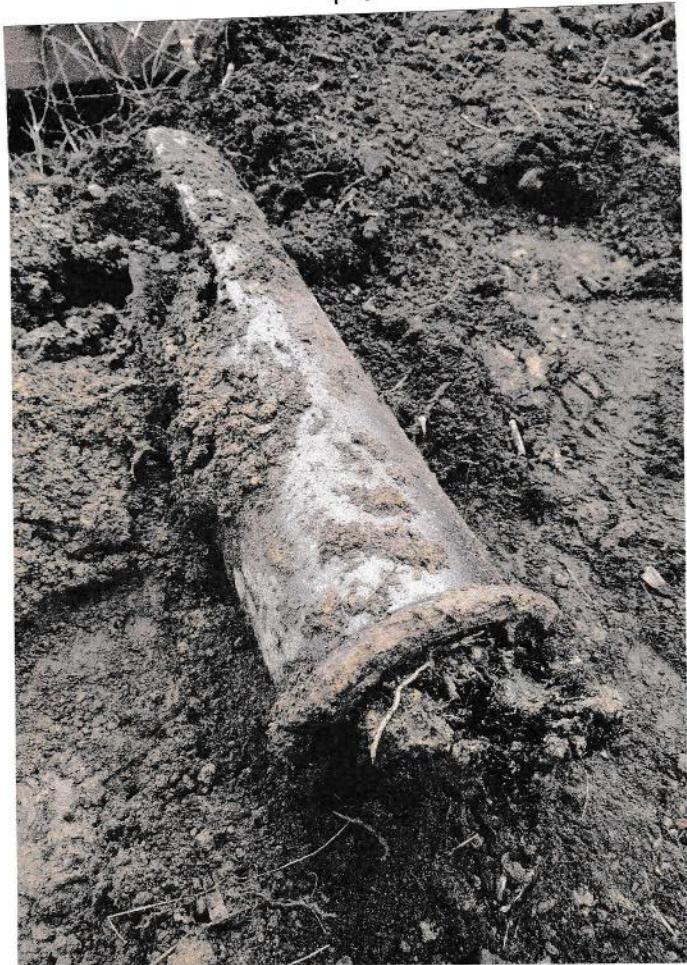
#1 V.C. pipe with
ROOT OBSTRUCTION
REMOVED/REPLACED

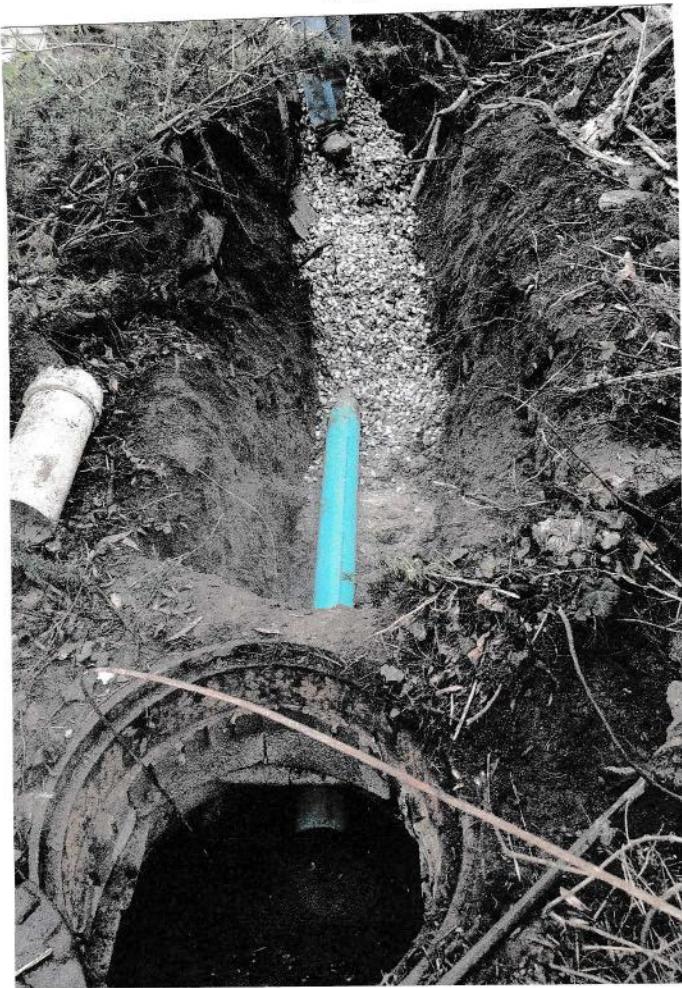
#2 SHOWS NEW PVC pipe
REPLACED TO THE
MANHOLE (10' new)

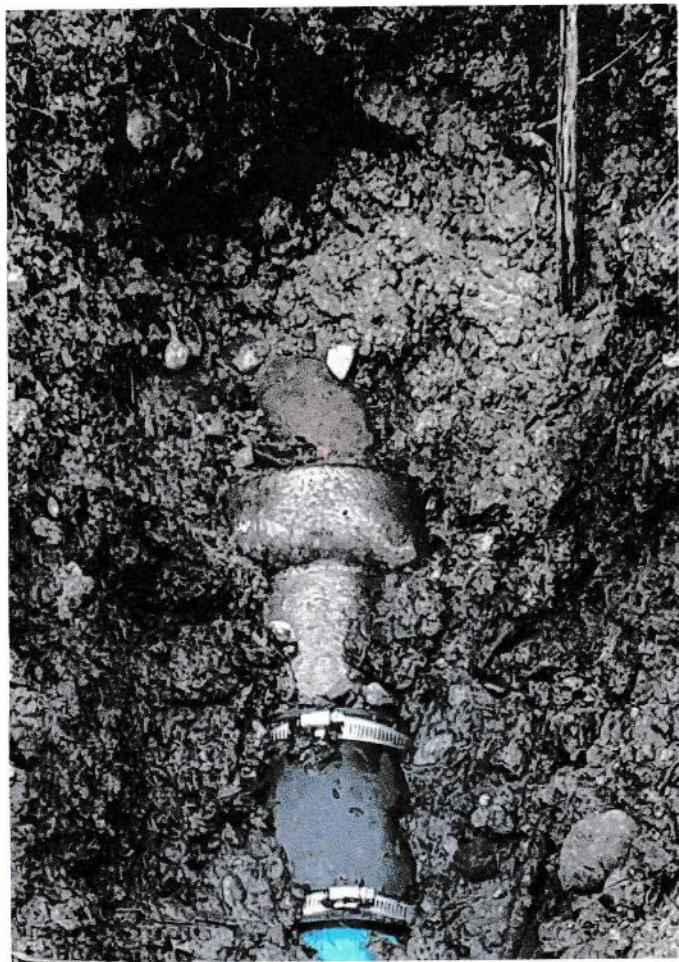
#3 UPSTREAM FERNO
Rubber COUPLING
REPLACED

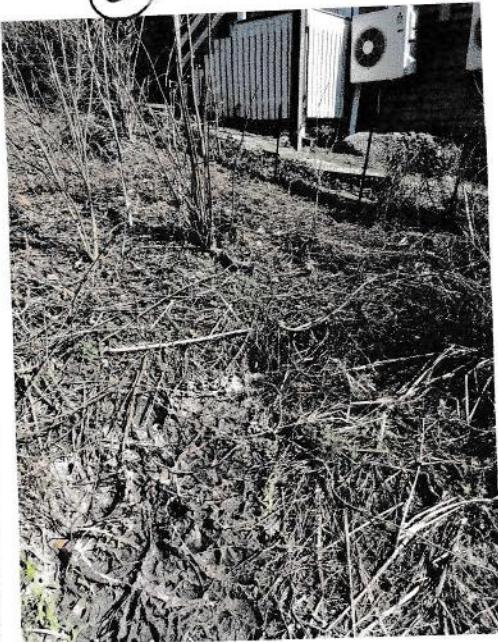
PICTURES
#1 + #2 - EVIDENCE THAT
SSO had occurred.

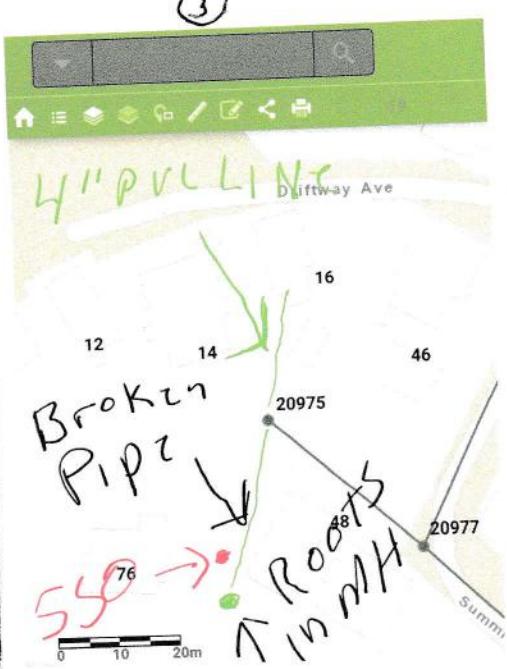
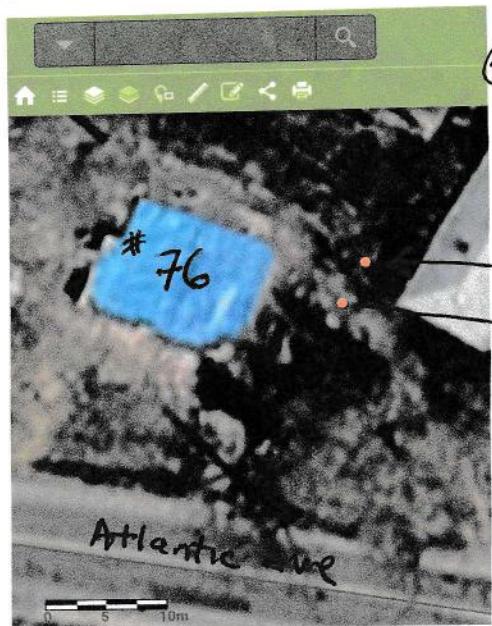
#3 + #4 show location
of SSO + downstream
MANHOLE off of Atlantic
Ave.

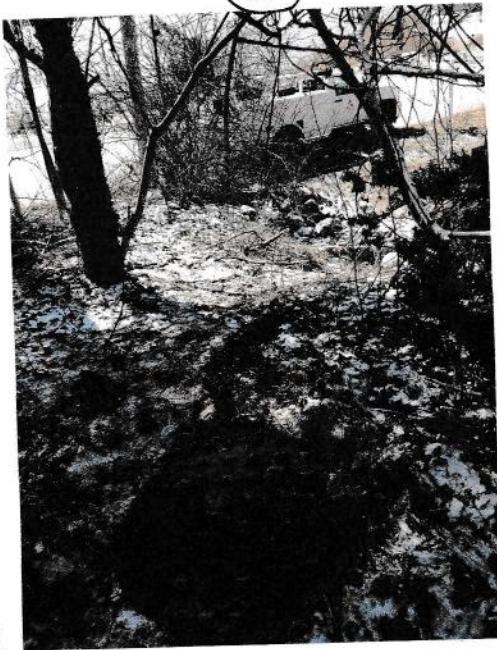
#3 Looking FROM MANHOLE
TOWARDS ATLANTIC AVE
#76 is to the right.
